DOT/FAA/CT-82/55

# **Examination of Aircraft Interior Emergency Lighting in a** Postcrash Fire Environment

June 1982

**Final Report**

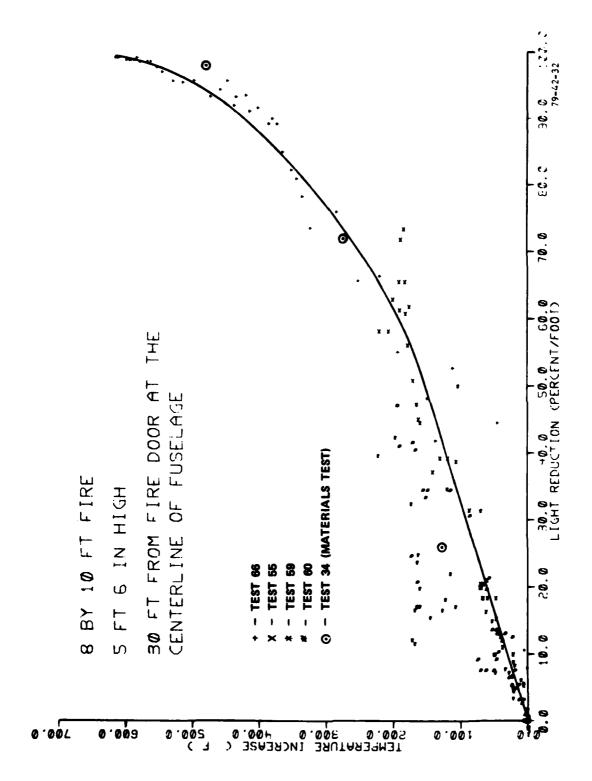
FIGURE 4. RELATION OF SMOKE-TO-TEMPERATURE INCREASE

According to page 59 of FAA-NA-79-42, (see figure 4),

$$\frac{\Delta \text{ (percentage light reduction/foot)}}{\Delta T} = \frac{60}{200}$$

where A T is temperature increase in degrees Fahrenheit. Thus,

$$\frac{I}{I_0} = 1 - 3(\Delta T) \cdot 10^{-3} \tag{1}$$

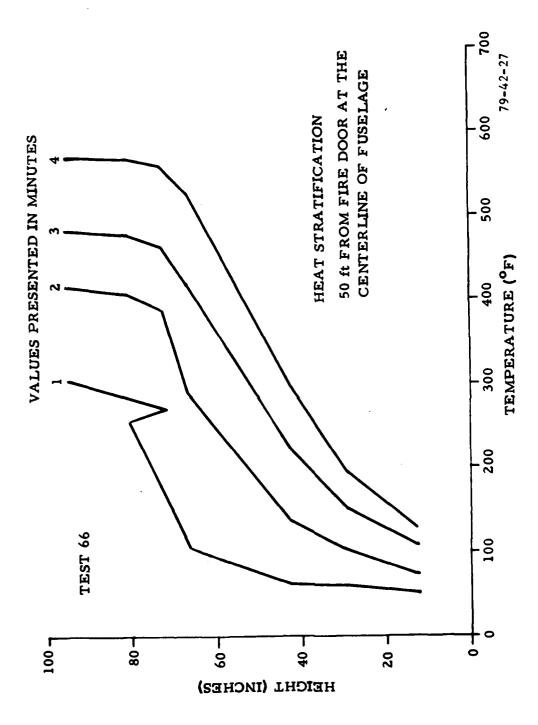
FIGURE 5. CABIN HEAT STRATIFICATION (REPLOT)

According to reference 8 (figure 5), the cabin vertical temperature profile is uniform over the top one-third of the cabin and decreases linearly to ambient over the bottom two-thirds of the cabin. Thus, if we tie the profile to any ceiling temperature  $T_H$ , we get two zones of actual temperature  $T^*$

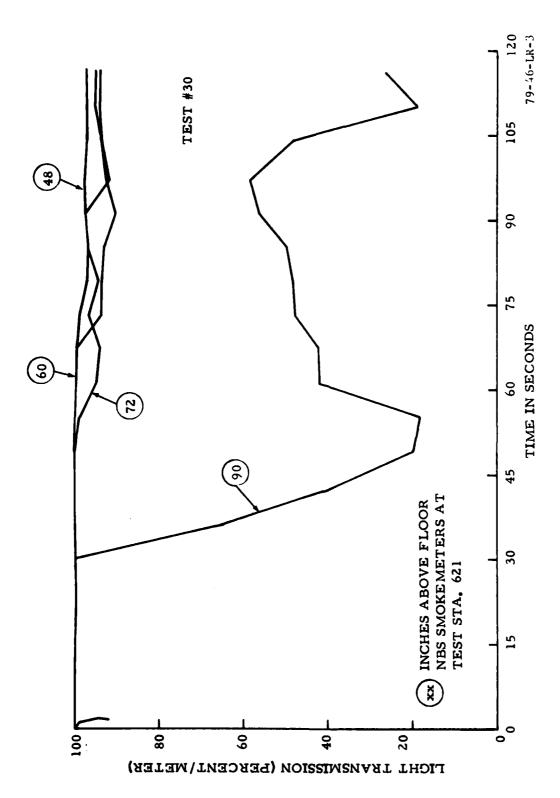
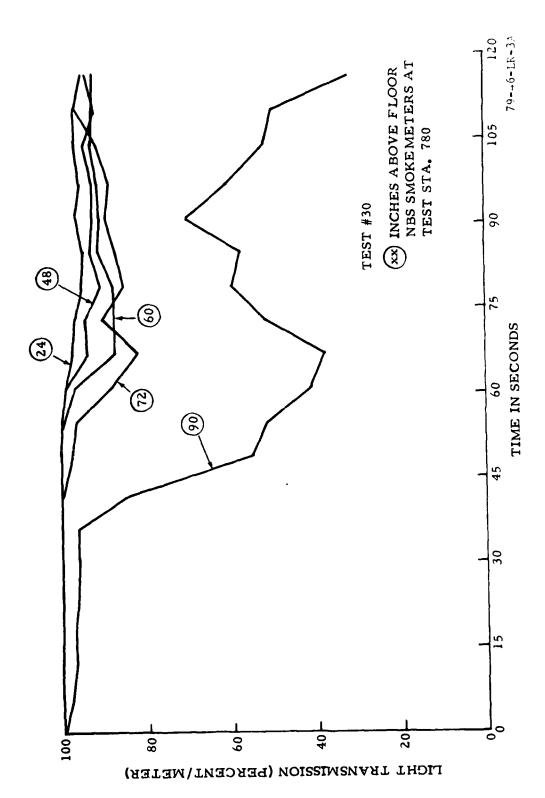
FIGURE 6. LIGHT TRANSMISSION (SMOKEMETER) PROFILE FOR "LIGHT SMOKE" ACCUMULATION AT STATION 621

FIGURE 7. LIGHT TRANSMISSION (SMOKEMETER) PROFILE FOR "LIGHT SMOKE" ACCUMULATION AT STATION 780

The light smoke conditions existing in test 30, shown plotted in figures 6 and 7, were a good example of a "thin" smoke layer. The light obscuration at 7 1/2 feet was significantly greater than at the remaining smoke meter locations (6 feet and below). Below the thin ceiling smoke layer, visibility was hardly impaired, and the temperature increase was insignificant (figure 8). Yet, although visibility was good and the conditions were survivable from a thermal viewpoint (reference 9), cabin illumination provided by the ceiling-mounted lights would have been significantly reduced by the "thin" layer of smoke near the ceiling.

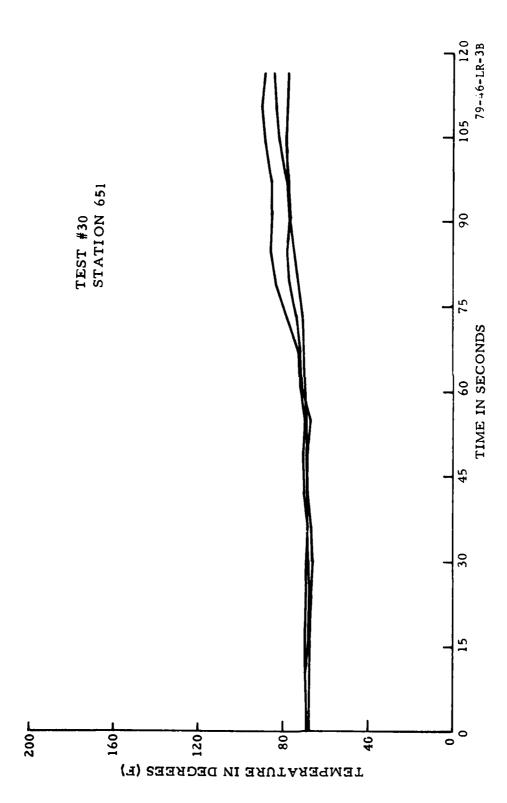
TEMPERATURE PROFILE AT THE 78-INCH LEVEL (EXIT SIGN LOCATION) DURING "LIGHT SMOKE" ACCUMULATION FIGURE 8.

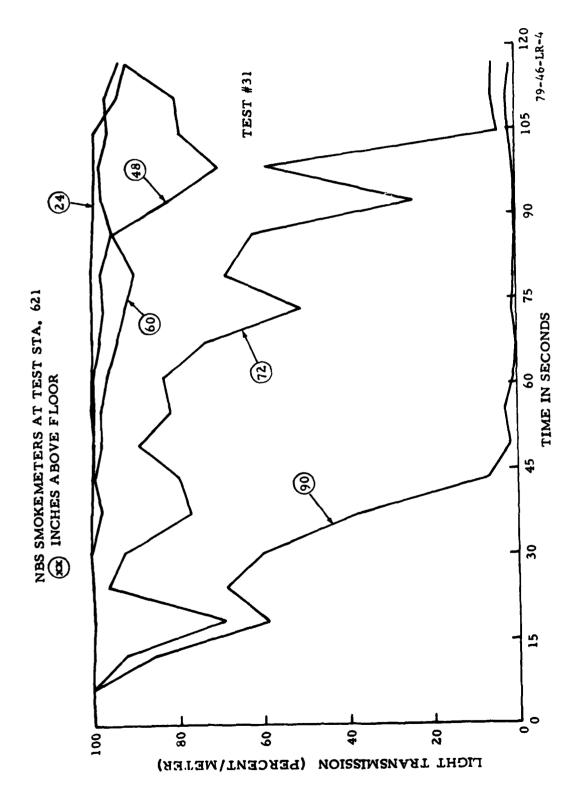
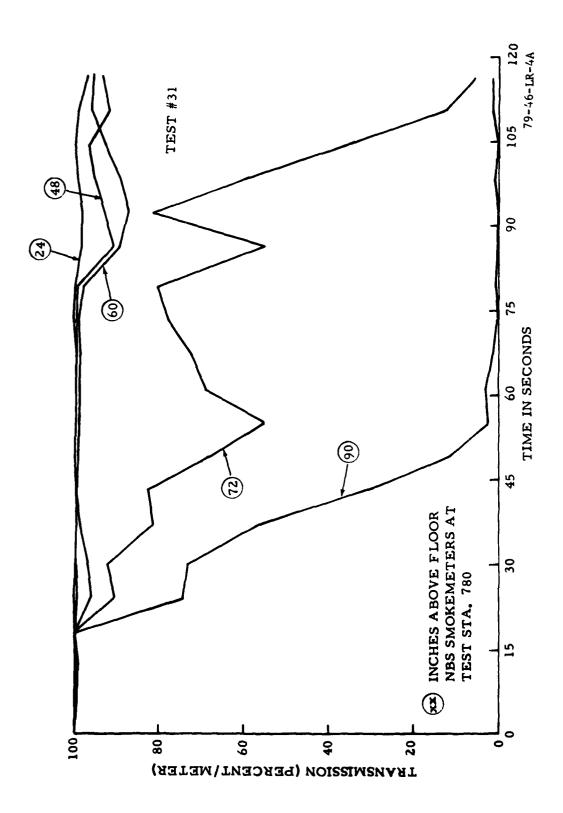
LIGHT TRANSMISSION (SMOKEMETER) PROFILE FOR "MEDIUM SMOKE" ACCUMULATION AT STATION 621 FIGURE 9.

LIGHT TRANSMISSION (SMOKEMETER) PROFILE FOR "MEDIUM SMOKE" ACCUMULATION AT STATION 780 FIGURE 10.

Light transmission data from test 31, is plotted in figures 9 and 10 and is an example of a medium smoke condition. Again, a very pronounced smoke layer is evident from the data presented, exhibiting a thickness of approximately 2 to 3 feet over the duration plotted. Thus, total light obscuration can occur within the smoke layer dimensions without subjecting a standing individual (66 inches) to a significant amount of heat stress (figure 11).

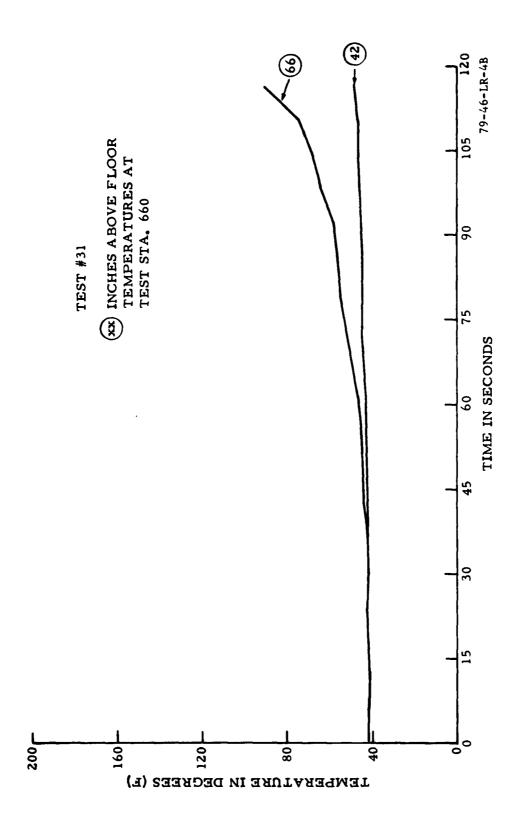
PIGURE 11. TEMPERATURE PROFILE FOR "MEDIUM SMOKE" ACCUMULATION AT STATION 660

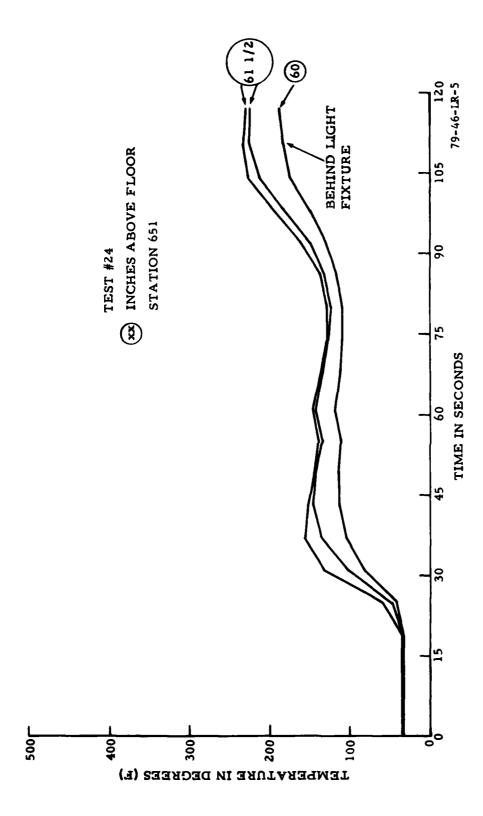
FIGURE 12. TEMPERATURE PROFILE DURING "MEDIUM SMOKE" "DENSE SMOKE" ACCUMULATION AT STATION 651

Significantly elevated cabin thermal conditions, but below human survivable levels, were produced in test 24. By 100 seconds, the temperature at the head of a standing individual was approximately 200° Fahrenheit (°F) (figure 12). Smoke accumulation data is plotted in figures 13 and 14. Although smoke stratification was still significant, it was not as pronounced as in tests 30 and 31.

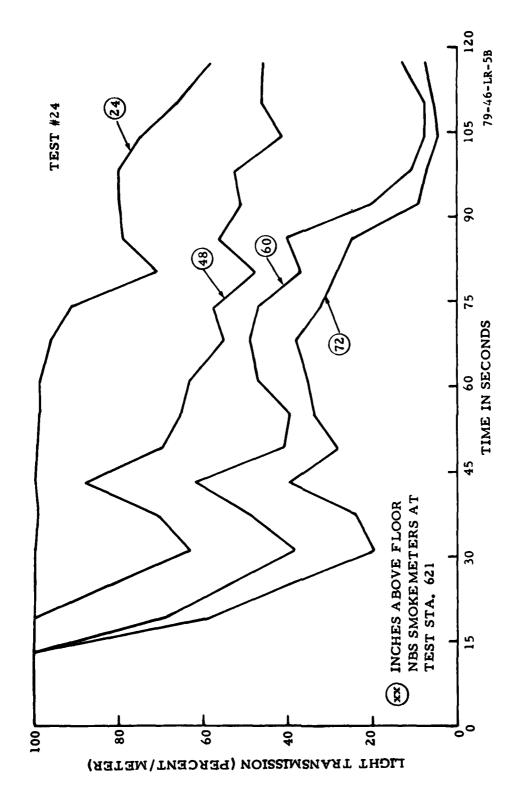
FIGURE 13. LIGHT TRANSMISSION (SMOKEMETER) PROFILE FOR "DENSE SMOKE" ACCUMULATION AT STATION 621

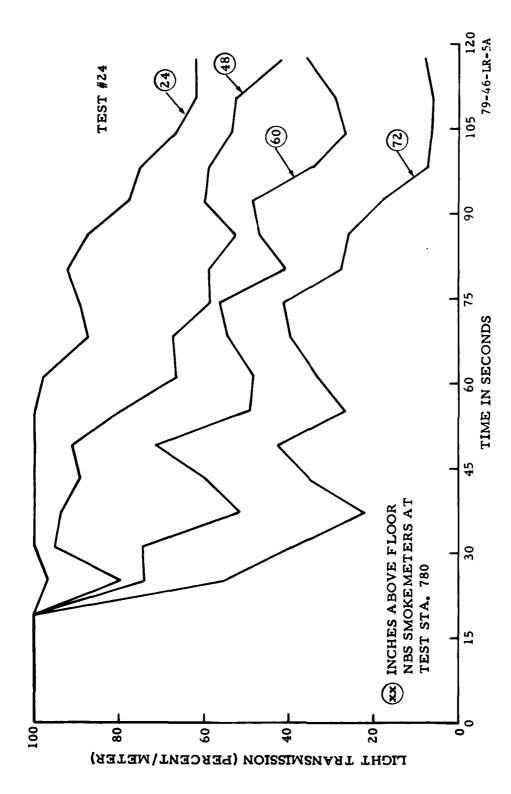
FIGURE 14. LIGHT TRANSMISSION (SMOKEMETER) PROFILE FOR "DENSE SMOKE" ACCUMULATION AT STATION 780

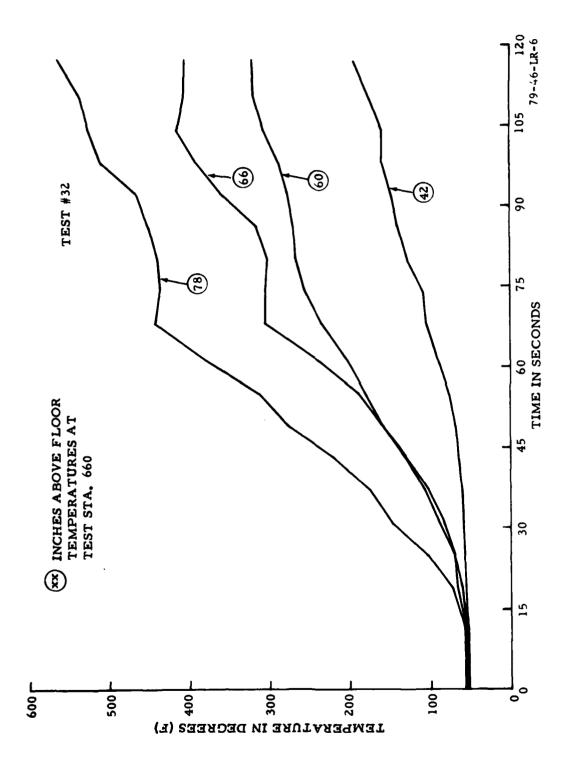
TEMPERATURE PROFILE DURING "VERY DENSE SMOKE" ACCUMULATION AT STATION 660 FIGURE 15.

Test 32 was one of the most severe tests and was an example of a nonsurvivable cabin thermal environment. At 2 minutes, the temperature at the head level of a standing individual exceeded 300 °F and was increasing (figure 15). A very pronounced smoke stratification was again evident. At 60 seconds, total light obscuration was measured 3 feet below the ceiling. Yet, the amount of light obscuration was only approximately 5 percent at a location 1-foot lower in the cabin (see figures 16 and 17). The smoke conditions measured at 60 seconds in test 32 were in excess of the maximum smoke densities that were used in the CAMI studies of the effect of smoke and cabin lighting on passenger visibility and emergency evacuation (reference 4). Optical density data at 60 seconds were in excess of 4.0 per meter, while during the CAMI evacuation tests, optical density values per meter ranged from 1.2 to 1.7 at the 72-inch level.

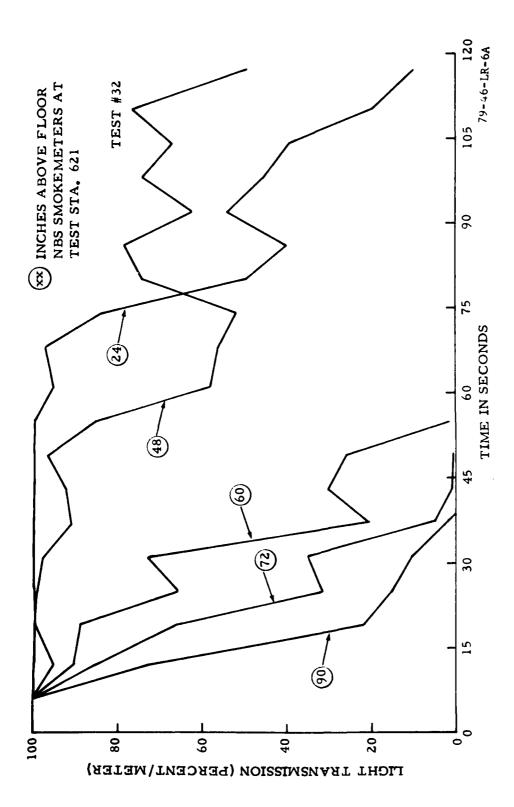
LIGHT TRANSMISSION (SMOKEMETER) PROFILE FOR "VERY DENSE SMOKE" ACCUMULATION AT STATION 621 FIGURE 16.

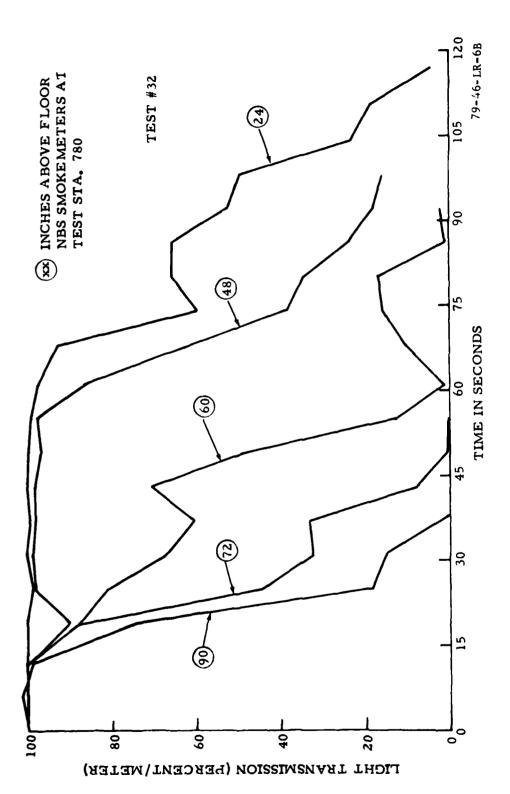
LIGHT TRANSMISSION (SMOKEMETER) PROFILE FOR "VERY DENSE SMOKE" ACCUMULATION AT STATION 780 FIGURE 17.

Figures 17 and 18 exhibit a "crossover" in smoke density at the 2- and 4-foot elevations. This "crossover" or inversion was observed in some tests and is believed to be a result of the entrainment of air at the exhaust door and recirculation of smoke near the floor.

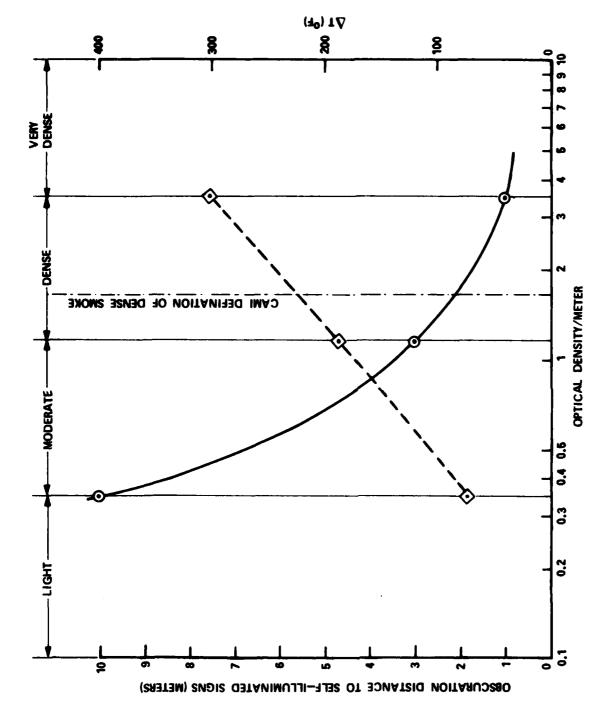
FIGURE 18. SMOKE-OPTICAL DENSITY CLASSIFICATION

## DISCUSSION OF SMOKE OPTICAL DENSITY CLASSIFICATION (FIGURE 18).

If smoke is injected into an enclosure, the resulting visibility depends on the volume of the enclosure, the rate of smoke generation, the geometry of the enclosure, and the physical and fluid dynamic actions sustained and effected by the

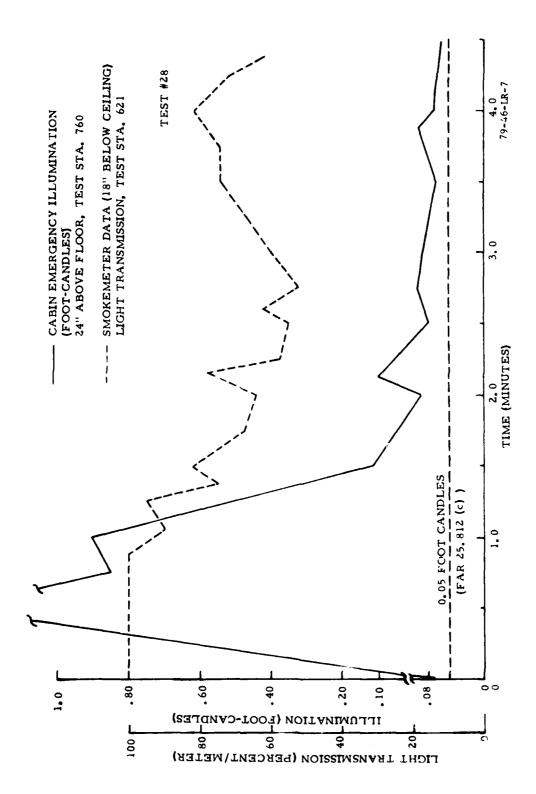
EFFECTS OF FIRE/SMOKE ON CABIN EMERGENCY ILLUMINATION, TEST 28 FIGURE 19.

Two photometers with remote probes equipped with cosine receptors were used to determine the decay of illumination in the cabin area at the armrest height (FAR 25.812(c)) due to smoke from an external fuel fire. The emergency interior cabin illumination was initially adjusted to provide 0.07 foot-candle height (the minimum value of 0.05 foot-candle was not attainable). During the light smoke conditions produced in test 28 (figure 19), the armrest illumination increased from 0.07 foot-candle to greater than 1.2 foot-candles, approximately 30 seconds after the external fuel fire was ignited. The increase in illumination was a result of light emitted by the fuel-fire flames penetrating the cabin environment. Although light transmission near the ceiling was eventually reduced to less than 40 percent, the fire provided illumination greater than the required 0.05 foot-candle at the armrest height, apparently, the smoke layer was not deep enough to obscure the flames from the external fuel fire.

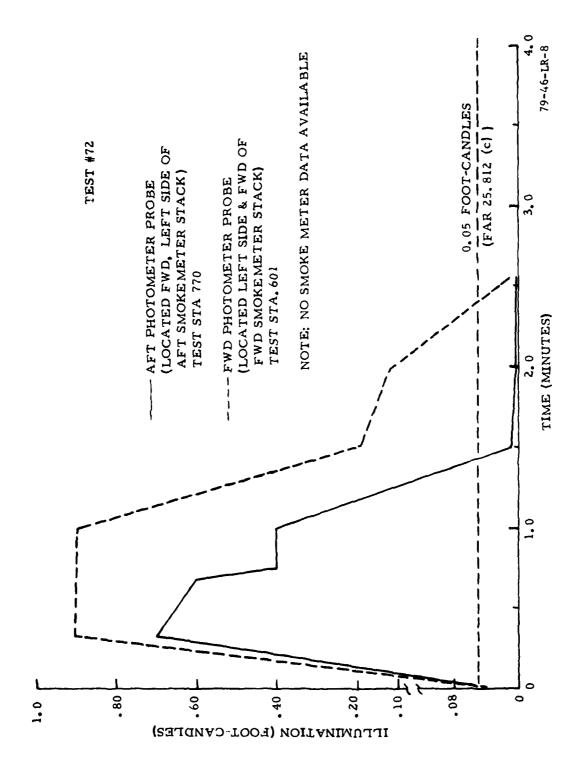
EFFECTS OF FIRE/SMOKE ON CABIN EMERGENCY ILLUMINATION, TEST 72 FIGURE 20.

Figure 20 contains data recorded during a much smokier test (test 72) where visual observations indicated "a very black smoke condition" at 52 seconds after the fuel fire was ignited and zero visibility at the 60-inch level at 120 seconds. Because it was closer to the fire, the forward photometer measured higher cabin illumination than the aft photometer. During this test the smoke in the cabin area became dense enough to obscure the external fuel-fire flames, and the photometers readings decreased steadily to zero. Thus, during a survivable postcrash external fuel fire, emergency interior cabin lighting may be overpowered by the illumination emitted from the flames, but eventually illumination from the fire will be blocked out by smoke accumulation.

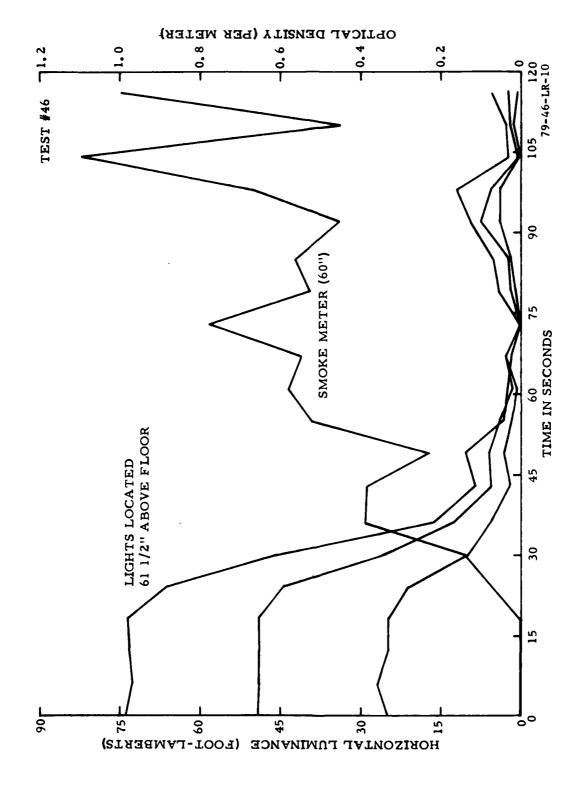
FIGURE 22. HORIZONTAL ILLUMINATION PROFILE VERSUS OPTICAL DENSITY

During test 46, the smoke conditions within the cabin were dense. Figure 22 indicates that the bright lights (50- and 75 foot-lamberts) provided illumination values higher than the required 25 foot-lamberts for only a short period of time beyond that provided by a "standard" light of 25 foot-lamberts — approximately 10 and 15 seconds, respectively. The data indicates that the different luminance values all reach a minimum value at approximately the same time. The smokemeter data recorded at the same elevation as the spotmeters exhibited the same behavior as the spotmeter data. Thus, heavy smoke accumulations can, and did, mask out any major benefits from increased brightness.

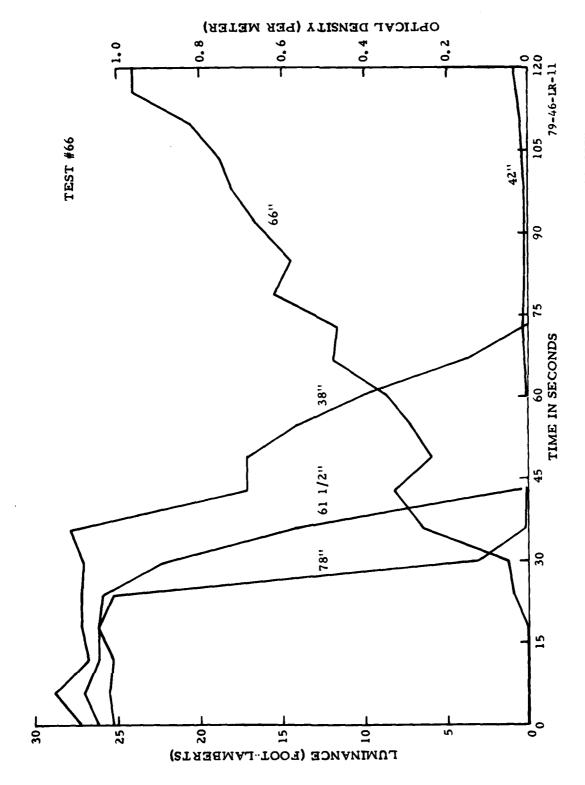
FIGURE 23. VERTICAL LIGHT ILLUMINATION PROFILE VERSUS OPTICAL DENSITY

The three vertical lights were adjusted as closely as possible to the same luminance. The three spotmeters were focused on the three lights, with the spotmeter viewing height fixed at 61 1/2 inches, as in the horizontal tests. Figure 23 presents data from test 66, which produced dense smoke conditions in the cabin area and indicate that lowering the lights will extend the time the lights provide passenger awareness information in contrast to previously described tests. transmissions data for this test were obtained from smoke meters developed and built at the Technical Center. These meters incorporated a light beam projected over a 1-foot distance onto a photosensitive device to measure light transmission, (reference 7). The data were converted to optical density per meter to keep values consistant throughout the report. The data indicates that lowering the light from the 78-inch level to the 61-1/2 inch level would only extend the time to attain total obscuration by 15 seconds, but if the light source were lowered from the 78-inch level to the 38-inch level, the time required to attain total obscuration would be extended approximately 45 seconds. The smoke optical density data in figure 23 indicate that the 78-inch and possibly the 61-1/2 inch light sources become covered by the layer of smoke near the ceiling; however, the lower light source (38 inches) would have remained visible if viewed from a height closer to its elevation. Thus, lights located closer to the floor would be highly beneficial to crouched individuals during evacuation of a smoke filled cabin. pictorially shows the value of locating lights below the 61 1/2-inch level used extensively for measurements in the study. Under the smoke conditions studied in the C-133, it is very difficult for the eye to receive any information from a sign or light located in the ceiling or above the door at the 78-inch level. A horizontal path of vision at the 61 1/2-inch level passes through less smoke, but the lower levels present the best location, since now the "eye" is only looking through the "corners" of the more dense smoke levels. During the evacuation stuides at CAMI (reference 4) lights and signs located in a normal configuration were of little or no value to evacuating passengers when the cabin was filled with smoke. A stooped position, looking down almost at the heels of the preceding passenger,

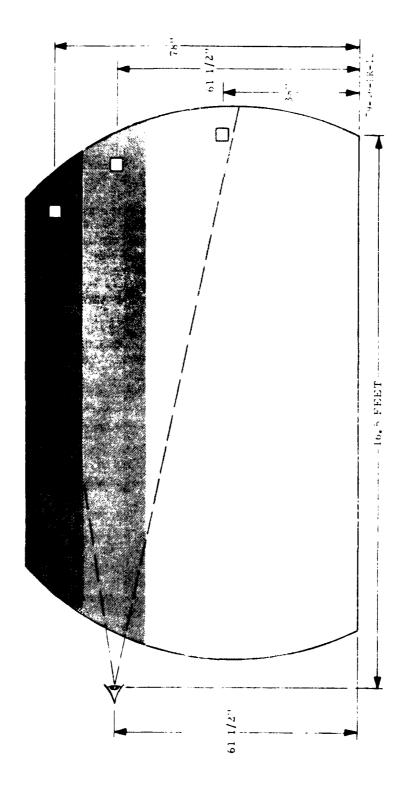
FIGURE 24. SMOKE LAYERING VERSUS "EYE LEVEL" OBSERVATION

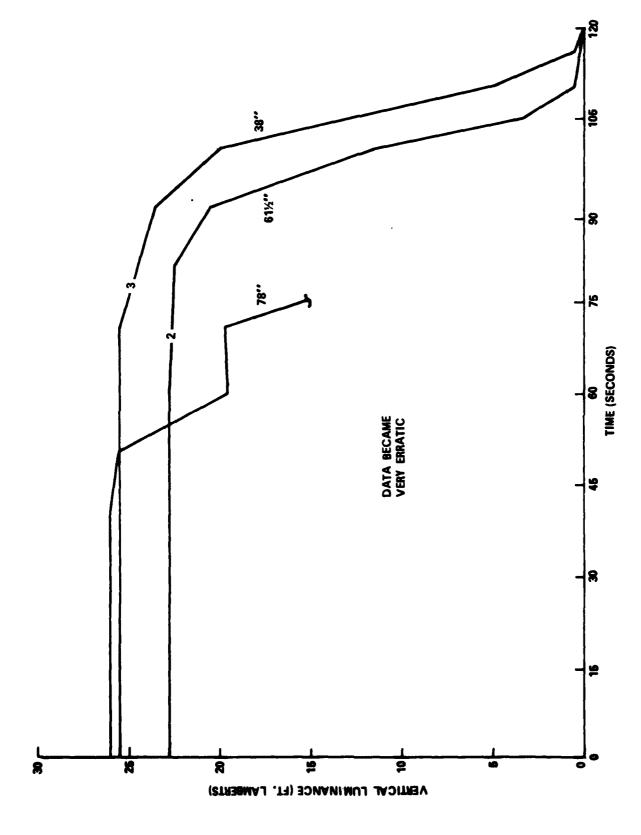
FIGURE 25. VERTICAL LUMINANCE PROFILE

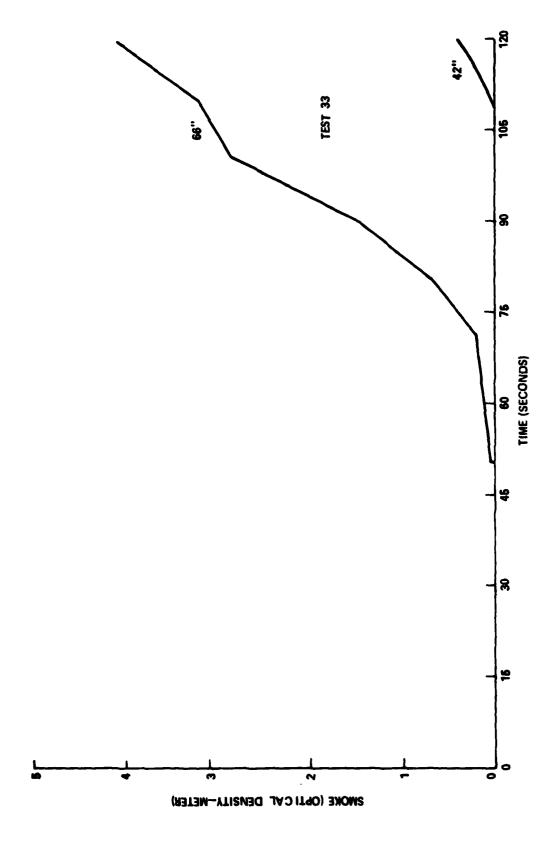
FIGURE 26. LIGHT TRANSMISSION (SMOKEMETER) VERSUS OPTICAL DENSITY
